# Malfunction Code Descriptions

For Buick 3.8L V6 SFI Turbo CCCI 84-87 Models

**The following is a list of ECM malfunction codes, a description of each, and instructions on how to extract them.**

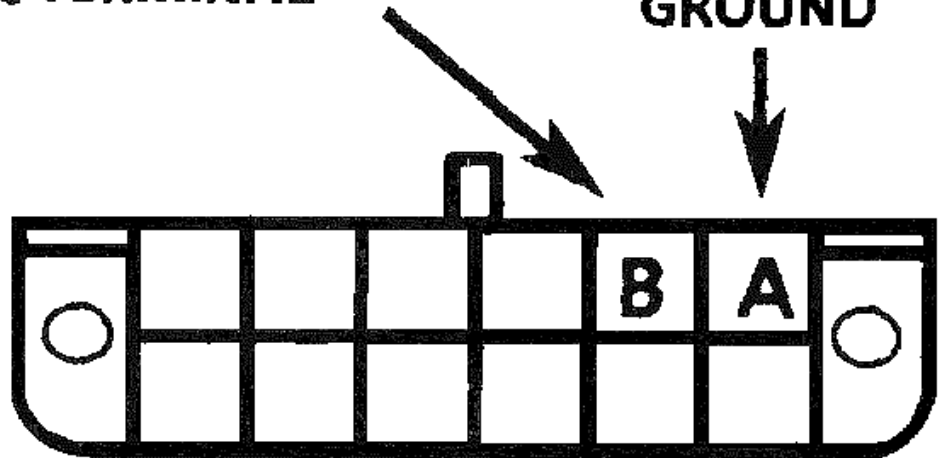
**ALDL CONNECTOR**

The ALDL connector looks like this

**DIAGNOSTIC TERMINAL**

**GROUND**

2. With ignition "ON" and engine "NOT RUNNING" use a jumper (paper clip) and connect terminal "B" to terminal "A". Terminal "A" is the ground connection.

1. First you must locate the ALDL connector which is located below the instrument panel (under radio).
